Manhole Inspection Summary

Manhole # S31AA2004MH

Insp Date: **4/17/07 10:58 AM**

Location Address: **123 CROYDON RD**

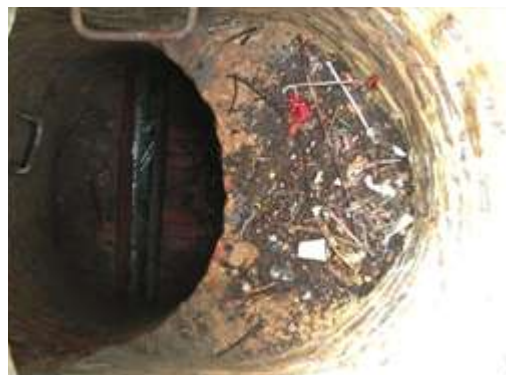
Top View

Adjustment deterioration and infiltration.
Corbel and Barrel infiltration. Bench
debris

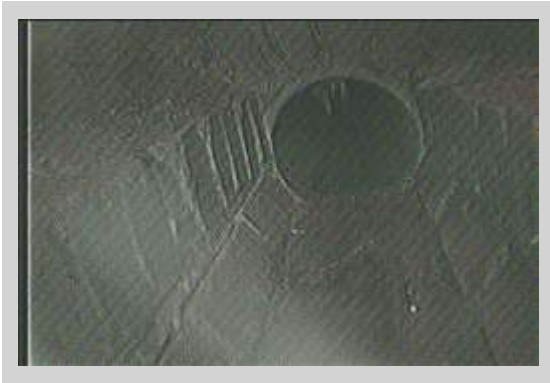
8 in. Circular Gravity Sewer Pipe Out @ 12 O'Clock

Channel deterioration.

Infiltration: **None** Pipe Seal Cond: **Cracked**

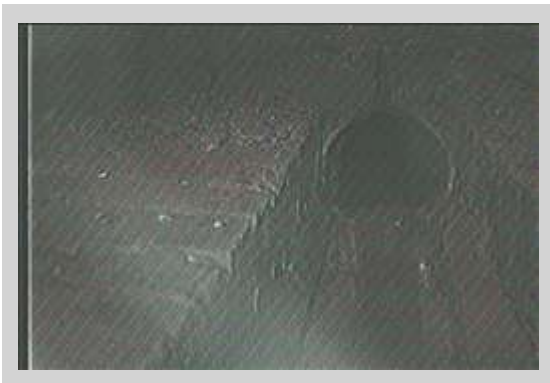
8 in. Circular Gravity Sewer Pipe In @ 6 O'Clock

Barrel deterioration and infiltration. Channel deterioration.

Infiltration: **None** Pipe Seal Cond: **Cracked**
